7 To the future - a discussion

7.01 Planning for the Immediate Future

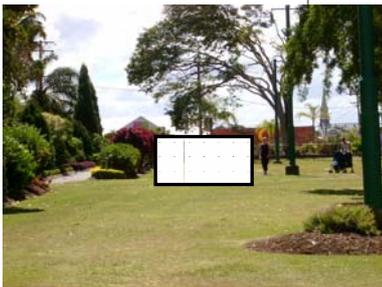
The visual intrusion into a space of exceptional heritage significance for both the sites nominated by MCC for the toilet block in the south-west of the park requires further enquiry. Either of the two sites under consideration would adversely affect the relationships to each other of the existing historic elements in this area and would destroy the status quo of the visual aesthetics of the space, highlighted in the images at left. Attention is drawn to Figures 16 and 20 pg.20 which show the existing toilet blocks visually intruding into the landscape space of the Historic Heart of Queens Park prior to the reinstatement of the shrubbery plantings along Judges Walk. Both selected sites also appear to be unacceptably close to trees of exceptional cultural heritage significance and therefore have the potential to adversely affect the health of these trees.

Location under consideration for a new toilet block near the Bazaar Street entry to Queens Park.

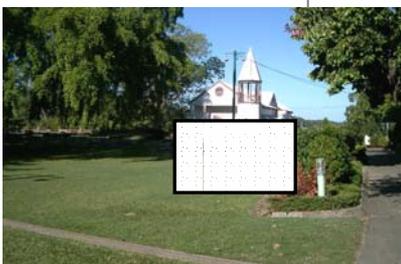
Alternative location under consideration for a new toilet block, on the park side of Judges Walk near the MELSA track entry to Queens Park.

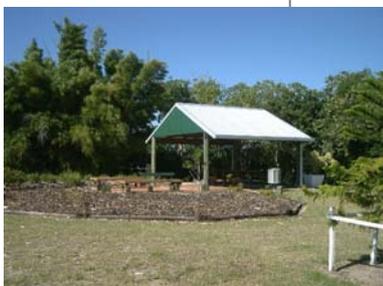
Vegetative backdrop to the new picnic shelter in the Vista Area of Queens Park. Behind this living screen is an outlook across the Mary river and Historic Heart of the park. Underneath the area is the crumbling embankment in Figure 48 pg.120.

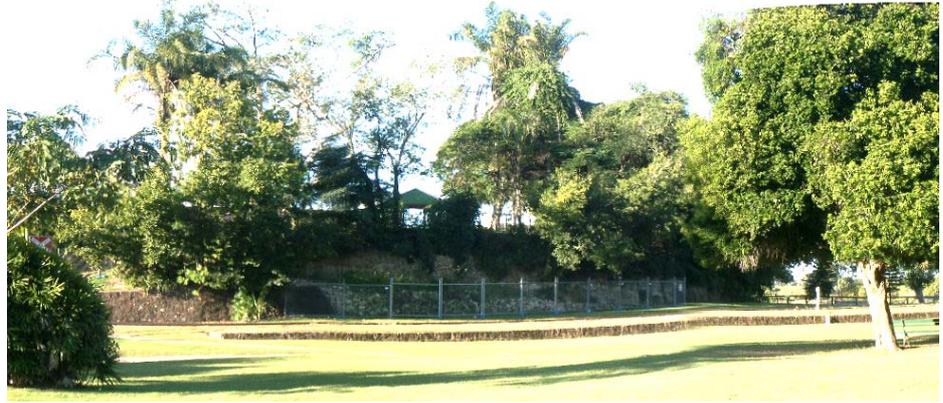
The stability of the embankment on the northern boundary of *The Saddle* landscape unit and the southern edge of the Vista Area Landscape Unit is in question. This embankment would initially have been formed by the course of the original Gardens Creek but was later modified by blasting to install the railway branch to Wilson Hart's Sawmill, which previously occupied the site of the Brolga Theatre.

A recent initiative to construct an access path up this bank from The Saddle to the Vista Area has been halted due to the instability of the bank and the failure of the path, as designed, to meet acceptable standards for public accessibility and safety. A poor level of access is therefore only available via the grassed slope to the west of the embankment or the vehicular track to the Sailing Club at the end of Walker Street. There is opportunity for the latter to be upgraded in association with future changes resulting from of the MURI RiverWalk initiative.

Figure 49. Note safety fencing installed along the crumbling section of this bank. The silhouette of the new picnic shelter can be seen above in the Vista area, Landscape Unit 9.

This bank is topped with a tangle of aging exotic vegetation which encloses the picnic shed and picnic area recently constructed here. The eastern face adjacent to the Sailing Club and the Mary River is rock faced. The south-eastern face into Queens Park appears to be crumbling and close public access has been prevented by temporary fencing.

Within that context, design of the Vista area needs to address two key issues: pathway connections with the body of the park, and treatment of its embankment. Direct access should be provided linking the Vista and Saddle areas, with the pathway meeting standards for disability access. With respect to a pathway alignment, the treed and grassy slope west of the Vista area and below the pumphouse/maintenance shed invites investigation, especially in association with a line of mature trees that form a partial avenue. An approach for the treatment of the destabilised embankment is a priority, in light of public safety issues. The pathway project already commenced should be abandoned at this time and the area secured.

Maryborough City Council has indicated that there is a high priority need to remove the temporary safety fencing from the face of the embankment for aesthetic reasons as much as anything else. They have budgeted to this end for the current financial year. To address the concern of the Maryborough City Council regarding the continued need for the safety fence around the embankment it is recommended that structural consultants be engaged to investigate and report on the stability of this area as first priority.

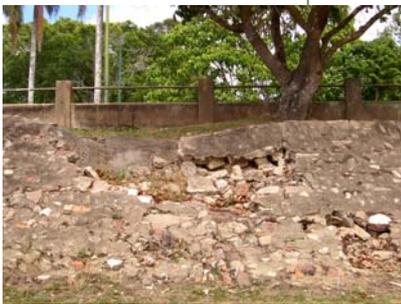
Eroded and crumbling rock faced retaining wall to the south of the sailing club entry area to Queens Park.

As mentioned elsewhere in this study, the stability of the retaining wall to the entire riverside boundary of Queens Park needs urgent structural assessment, short term repairs and long term design detail consideration, in both structural and aesthetic terms. This area is not strictly within Queens Park and as such is not included in the entry for the park on the Queensland Heritage Register. It's stability is of vital importance to the park however, particularly in the light of the regular flooding experienced in the area. Failure of this eastern retaining wall could see a substantial amount of Queens Park subside onto the bank of the river.

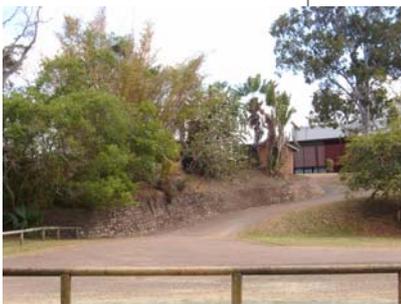
Rock faced retaining wall to the north of the sailing club entry area to Queens Park in good repair.
