Location Plan:		Kingfisher Parade Seawall	
	Date:	30 November 2017	
	Engineer:	Gildas Colleter	
	DEHP Coastal Segment:	FRC047	
	Start coordinates	152.671764232, -25.2449565559	
	End coordinates	152.675724521, -25.2458581927	
	Tide	Low during inspection (3 hours on-site)	
	Asset Certification	Yes, RPEQ	
	Other associated assets	Stair access Beach accesses Fence Signs Private properties	
NOTE: This document has been prepared as an Asset Condition Survey Report for Fraser Coast Regional Council. JBP accepts no responsibility or liability for any use that is made of this document other than by the Client for the purposes for which it was originally commissioned and prepared.

Structure type:	Rock armour revetment		
Approx. defence length (m):	375m		
Approx. co-ordinates from:	152.672570672, 25.2450582158	to:	152.67518283, 25.2455802775
As built drawing available:	Yes		
Infrastructure protected:	Private property and public land

COASTAL ASSET CONDITION SURVEY REPORT

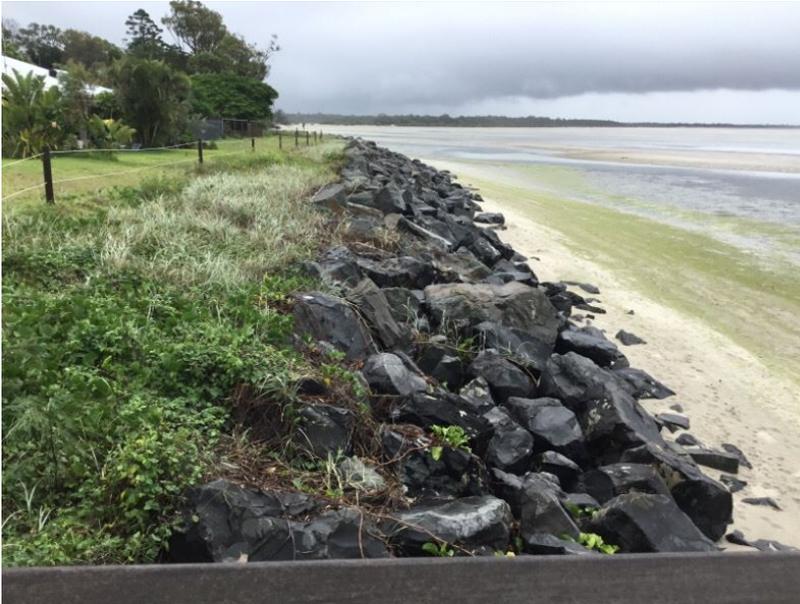
Looking west - seawall trunk is exposed and the toe is buried – Location Reference 2

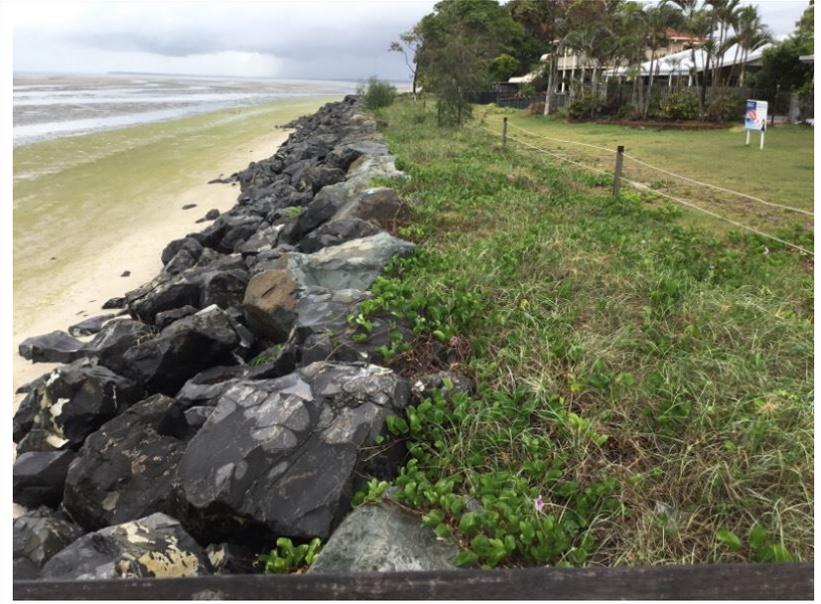
Looking East - seawall trunk is exposed and the toe is buried – Location Reference 2

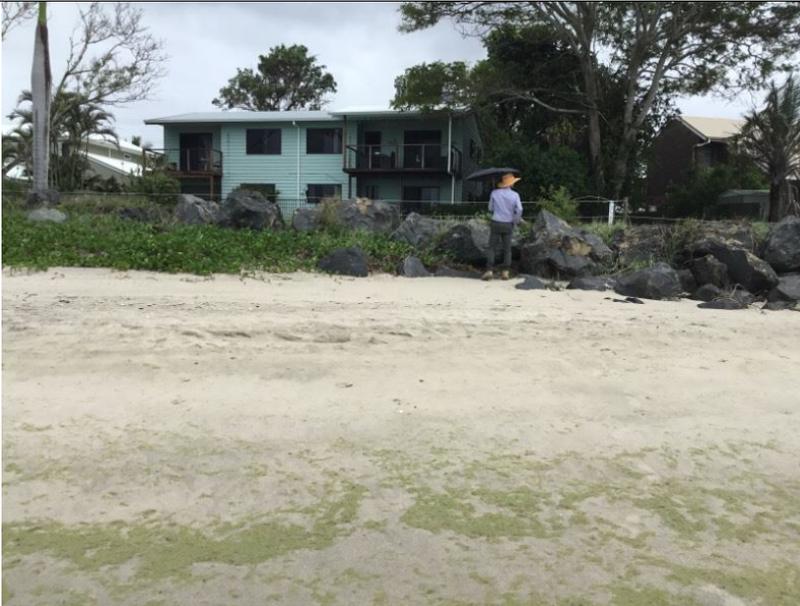
The seawall toe and trunk sections are buried – Location Reference 20

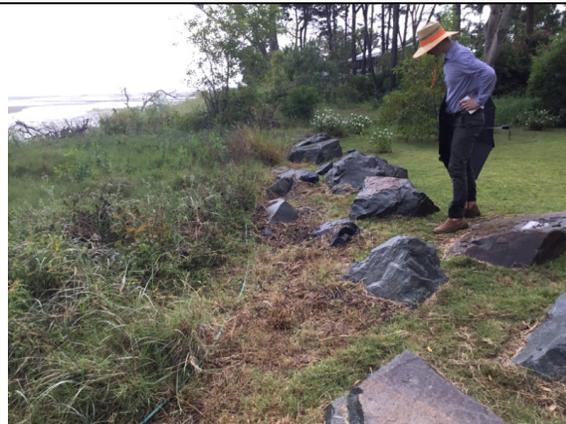
**Dune erosion to west – capping stones-
Ref No: P3**

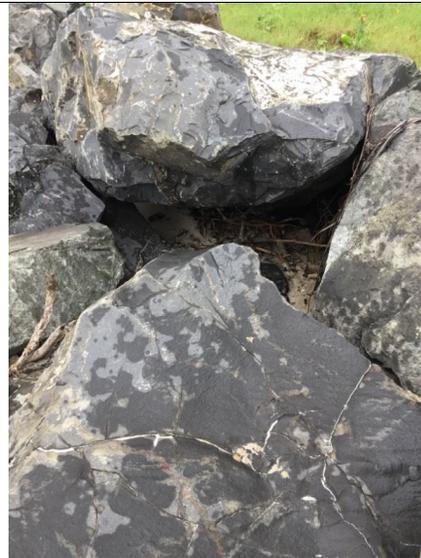
**Defect D1: Entrapment void
Ref No: P20**

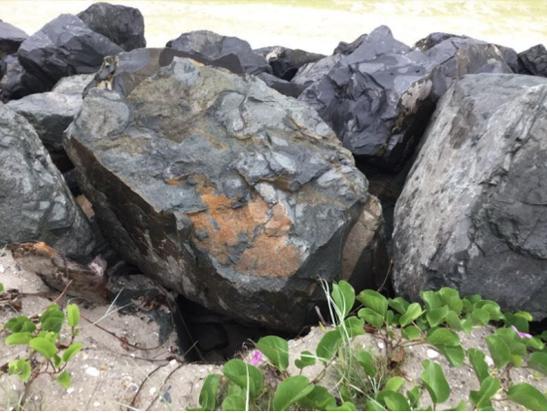
Defect D2: Void at crest due to localised sand slumping
Ref No: P12

Close void in between capping stones at the crest with rock spalls	D2	72,

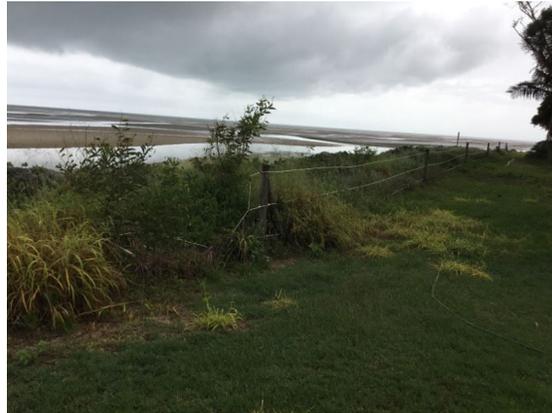
Defect D3: Interruption of western fence
Ref No: P21

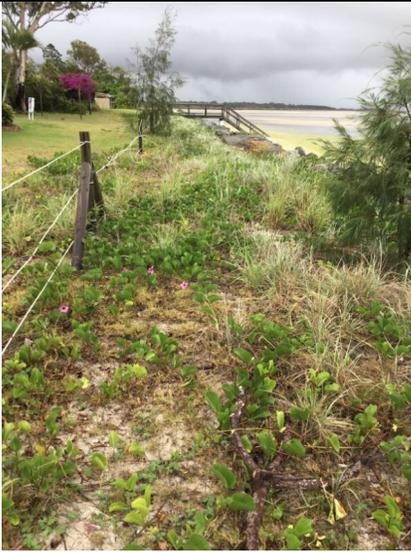
Defect D4: Fence wire disconnected
Ref No: P12

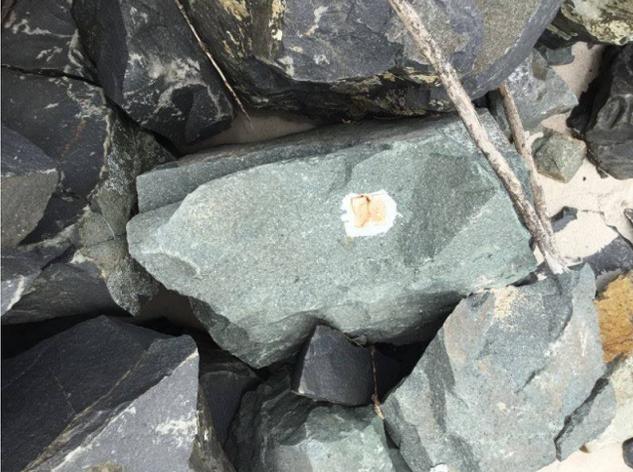
<p data-bbox="300 751 1495 774">Damaged since November 2015. The armourstone seems not to be originating from Dundorwan Quarry</p>
ID49

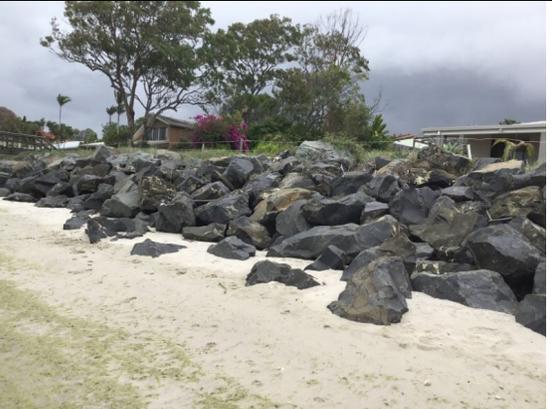
N=24, D=1	N=18, D=0 – Unpacking of 1 armourstone, some spalls
#66

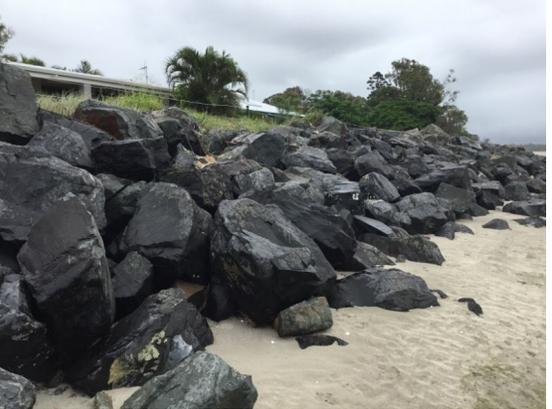
N=16, D=0	N=16, D=0 – high packing density

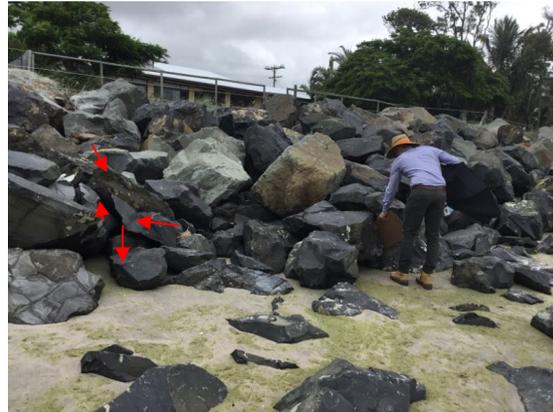
Damage 2 - multiple fractures and residual armourstone likely 750kg or less - #60

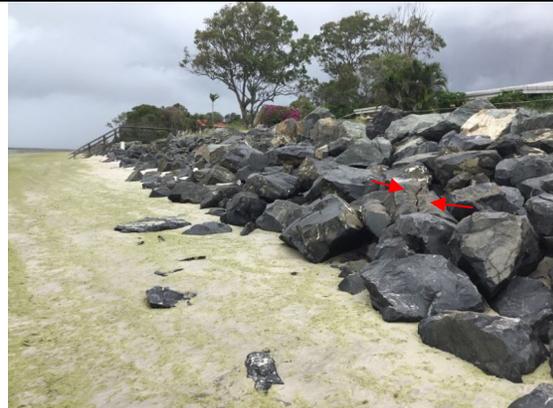
Damage 4 - Residual armourstone likely 750kg or less - #62

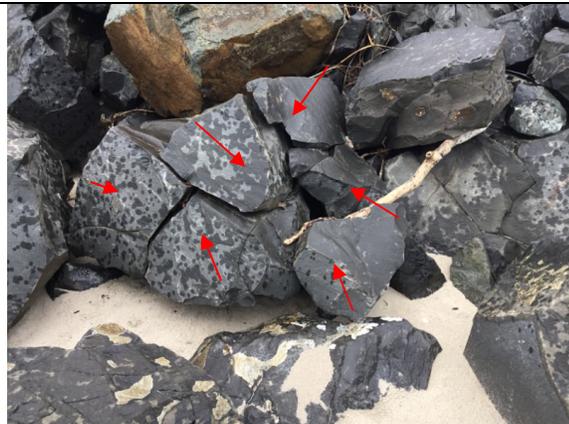
Damage 5 - multiple fractures and residual armourstone likely 400kg or less - #64. Multiple fracture planes

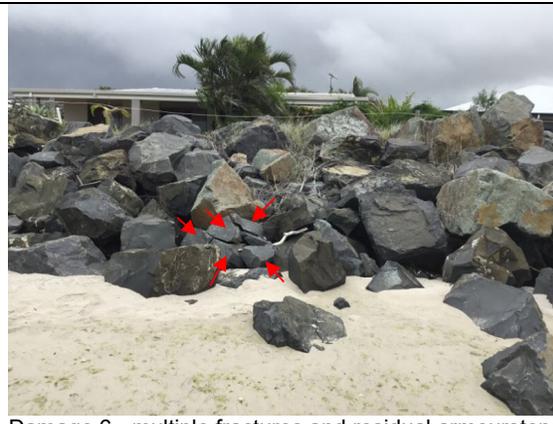
Damage 6 - multiple fractures and residual armourstone likely 750kg or less - #64

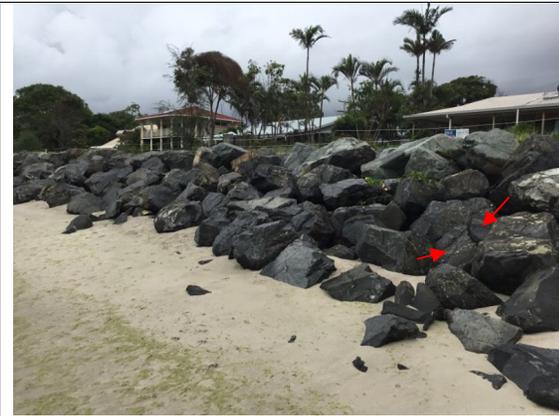
Damage 7 - multiple fractures and residual armourstone likely 750kg or less - #70

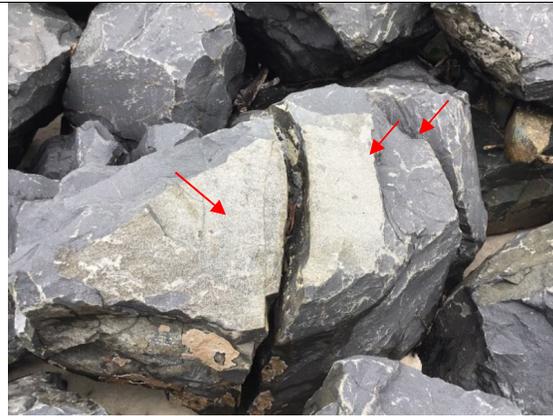
Damage 8 - 3x fractures main armourstone likely ~ 750kg or less #70

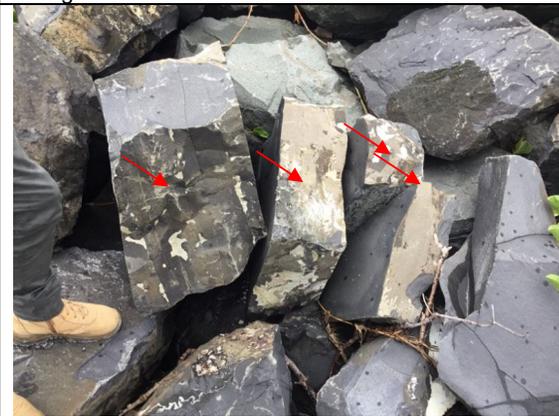
Damage 9 - multiple fractures planes and residual armourstone likely 400kg or less - #72

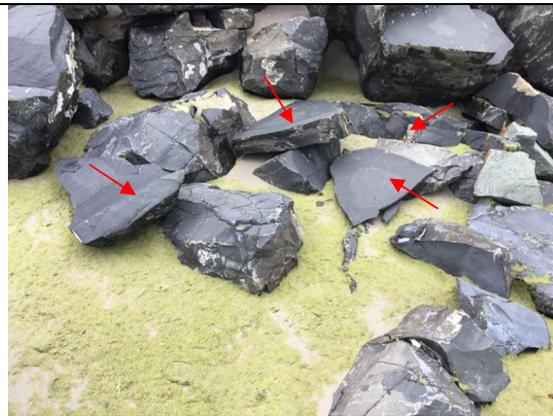
Damage 10 - multiple fractures plane and residual armourstone likely 100kg or less - #76

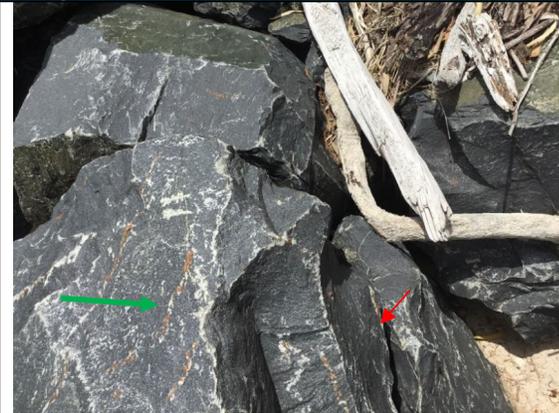
Defect - Spalling, armourstone likely >>1t mass - #50

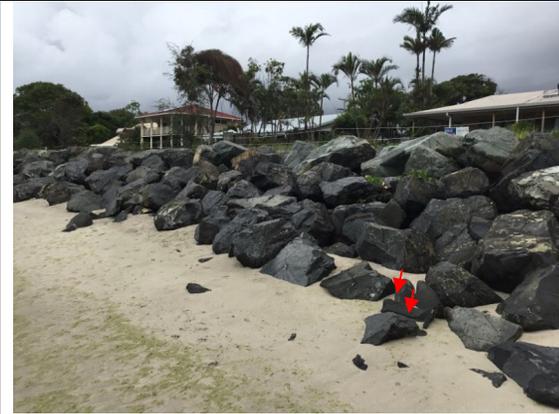
Defect – Rock spalls, could be relocated in armour voids #70

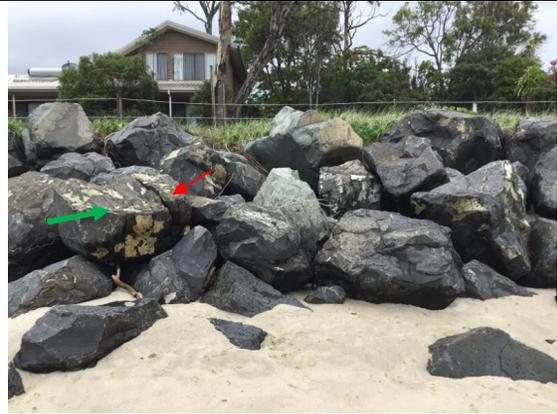
Defect- spalling with main armourstone likely >>1t - #70

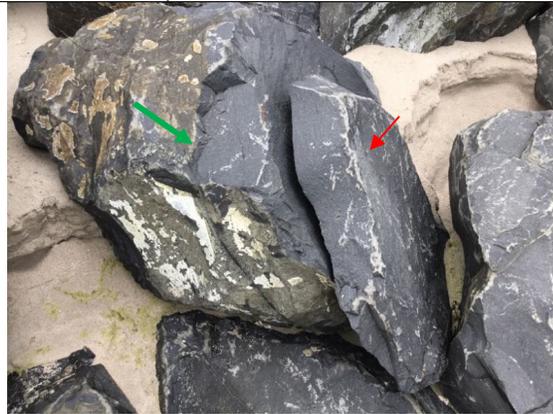
Defect- spalling with main armourstone likely >1t - #74

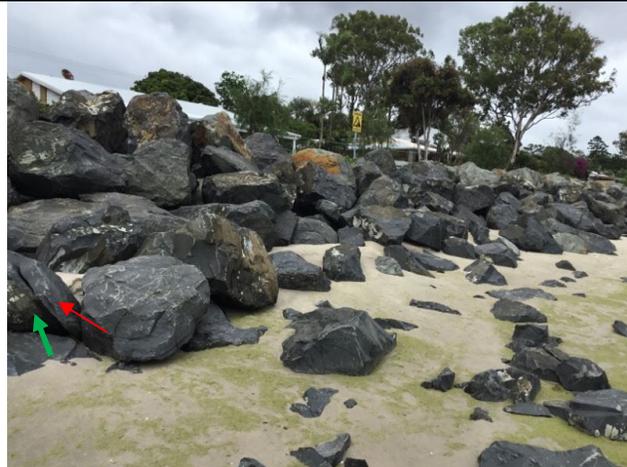
Defect- spalling with main armourstone likely >1t - #72

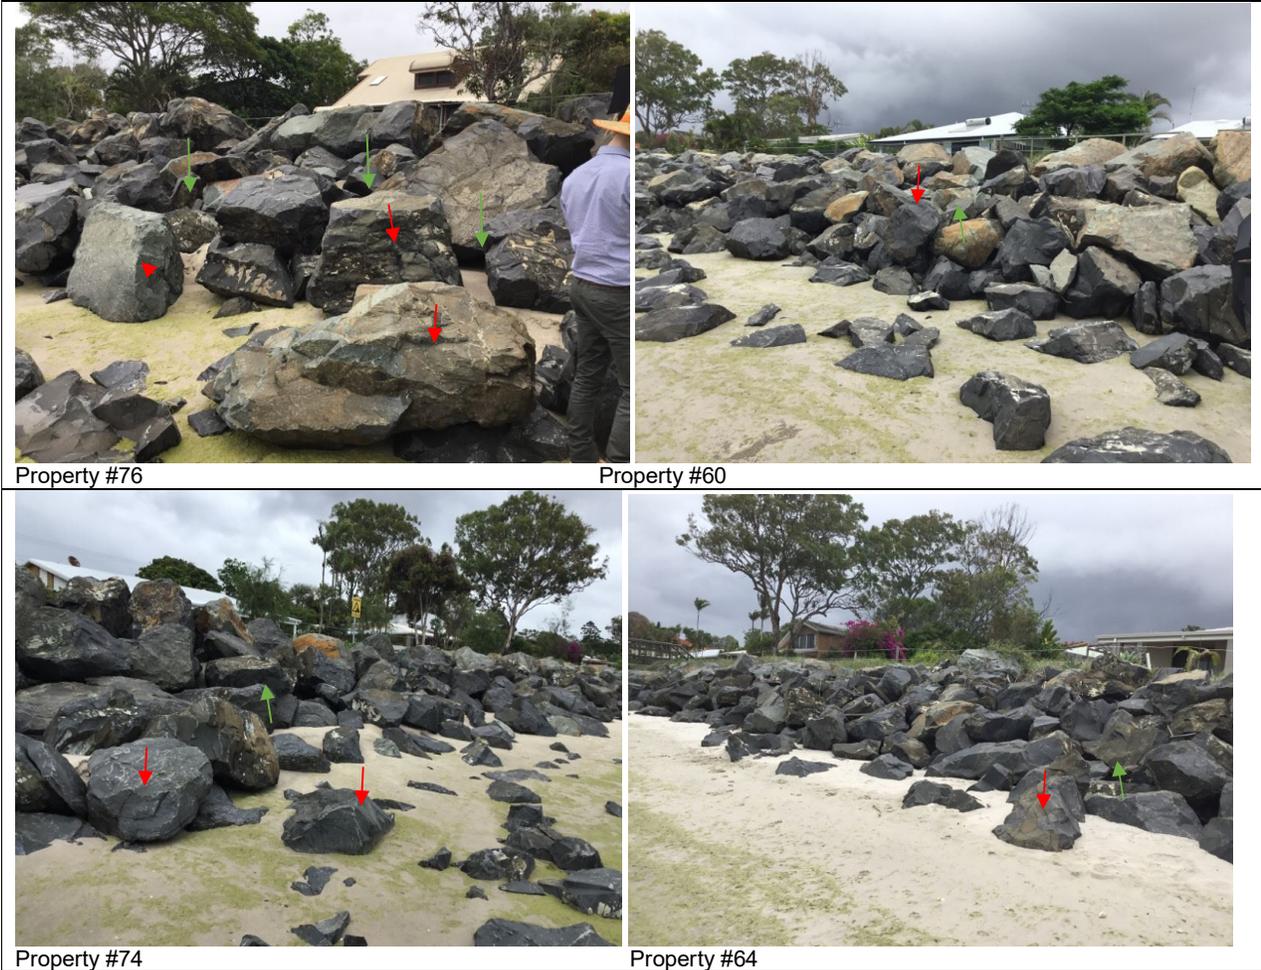
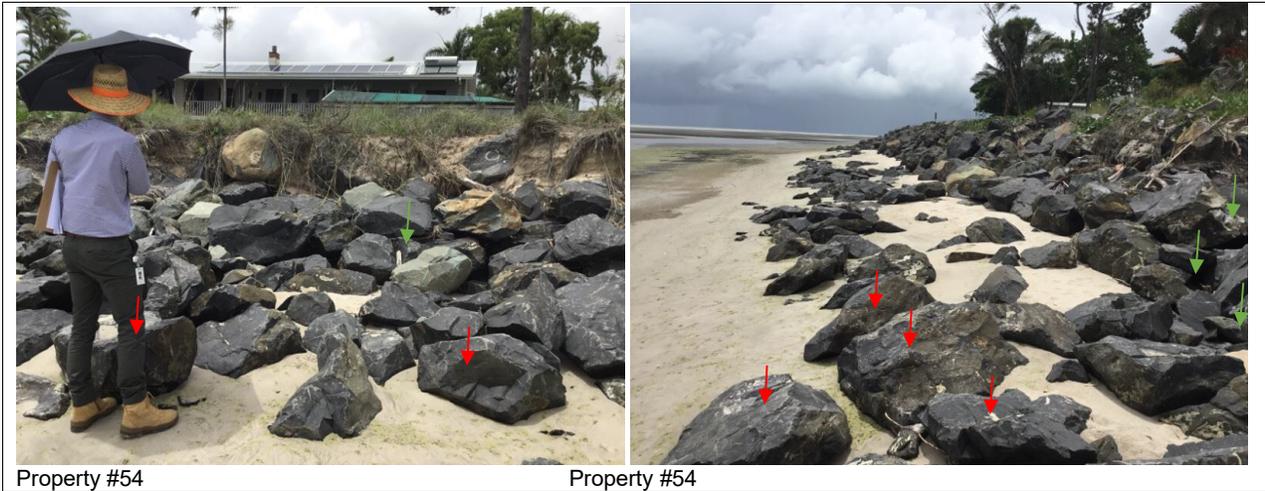
Property #54

Some localised individual armourstones have moved since construction. This generate some localised low packing density along the structure. This defect, D6, maybe more prevalent where the seawall is being uncovered by dune erosion.

It is recommended to increase local interlocking and packing density where armourstones are isolated, particularly on the trunk of the seawall. The photograph below shows individual stones isolated from the armour which should be re-interlocked tightly into the trunk of the seawall. It was not possible to make an exhaustive record of the number of stone to be re-packed onto the structure. A ball-park estimate of 40 to 60 armourstones is likely sufficient to regain a very good packing density overall.

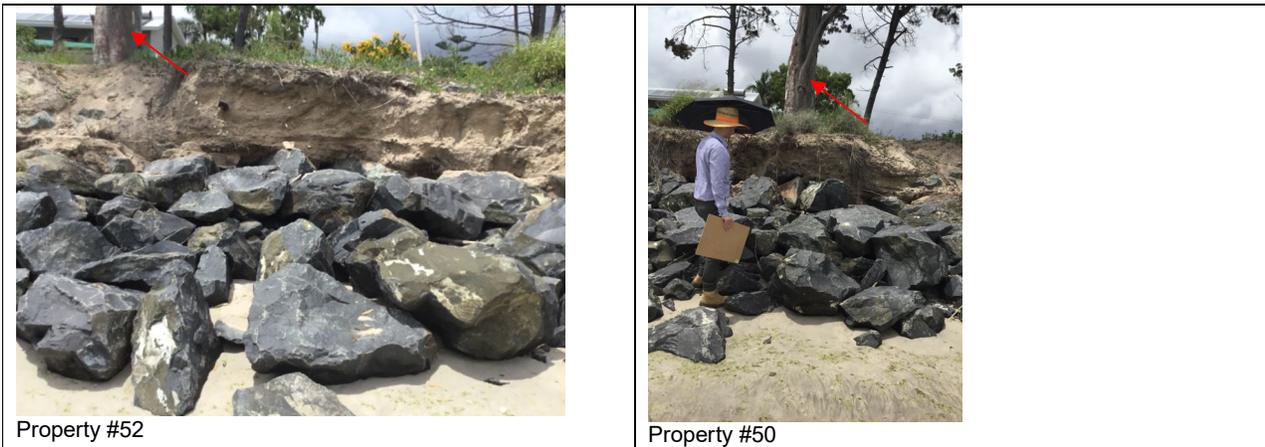
There may be a few larger trees near the erosions scarp. The position of large trees in relation to the seawall crest should be ascertained to trigger lopping or removal of tree if required.

The scarp is unstable and could collapse, therefore access should be restricted (fencing) and the erosion scarp hazard should be indicated along the crest (erosion scarp >1m).
