### 3.02.09 Vista Area

### 3.02.10 Pathways through Queens Park

### 3.02.11 Edges to Queens Park

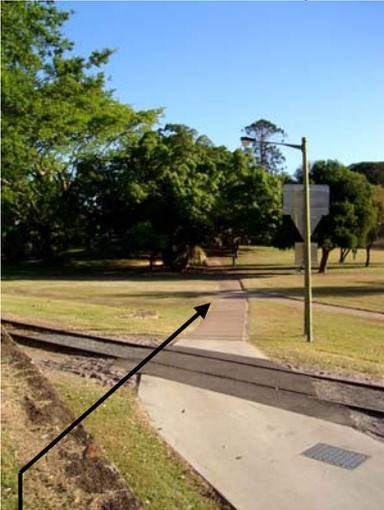
Intersection of the north-western diagonal entry pathway with the railway crossing and the historical crossing of Gardens Creek

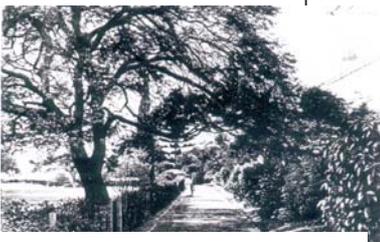
Judges (Top) Walk looking East circa 1910

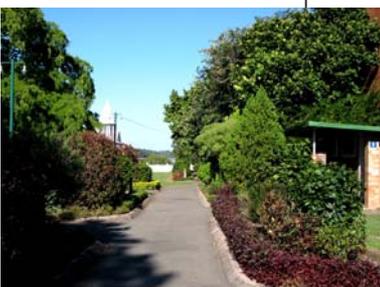
Judges (Top) Walk looking East 2003

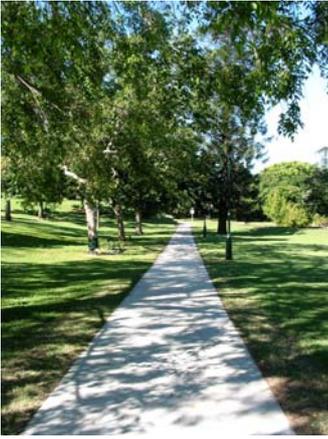
North western entry path looking towards the railway line crossing

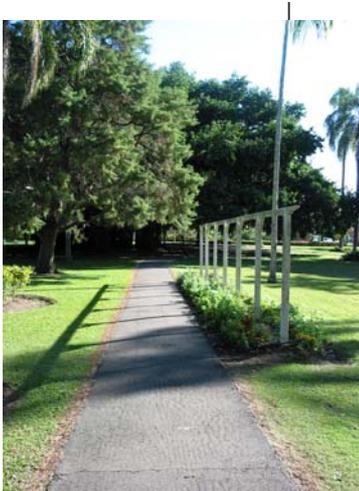
Pathway through the Historic Heart looking from the riverbank towards the Banyan Tree that is potentially on the alignment of part of the inner perimeter pathway indicated in the 1893 indicative path layout.

Pathways through the Historic Heart of the gardens have changed in relation to the change in the size of the circular ornamental gardens. Parts of some of the current pathways through this area may coincide with parts of the sweeping curve of a perimeter pathway indicated on the 1893 plan. This inner perimeter pathway encircled the area of the park that was to the south of Gardens Creek and enfolded within the constraints of the river bank and the central ridge from the end of Adelaide Street. A partial outer curved perimeter pathway is also shown on the 1893 plan to the south-west of the park. No evidence remains of this path today.
