| AHC Category | Archaeological | Historic | Indigenous | Landscape |
|---|--|---|---|---|
| Address/Location | Scarness Foreshore, Esplanade, Scarness | | | |
| Place Components | Band stand | | | |
| Inspection Date | 31/01/2025 | | | |

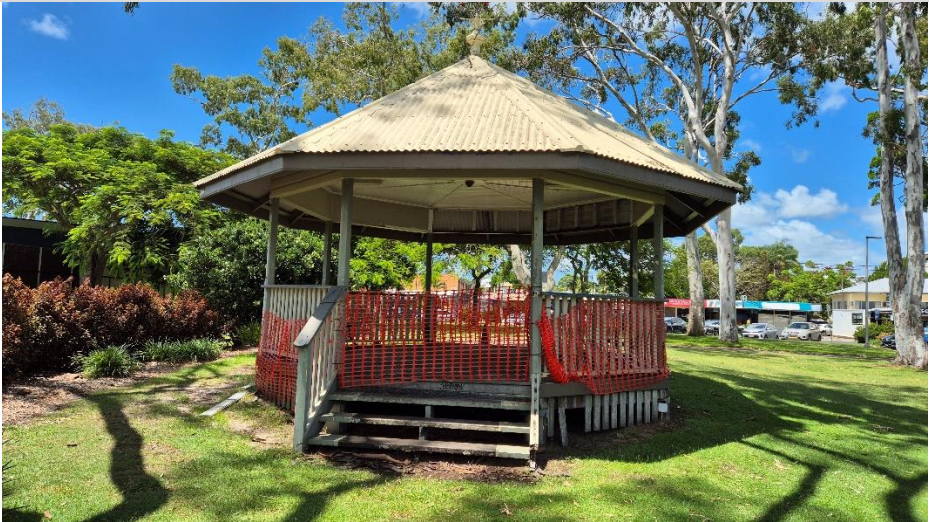
| AHC Category | Archaeological | Historic | Indigenous | Landscape |
|---|--|---|---|---|
| Physical Description | The Scarness Band Rotunda is situated in the Scarness foreshore reserve in a landscaped setting. It consists of an octagonal, lowest timber structure on stumps covered by an octagonal, pointed, corrugated metal clad roof, supported on timber posts and lined with jointed timber boards. What appears to be the original finial is located at the apex, surmounted by a later weathervane. The original, half height side walls have been replaced with a slatted balustrade. Access is via timber steps as well as an additional ramp. | | | |
| Integrity | Fair | | Condition | Fair |
