Location Plan:		Kingfisher Parade Seawall	
	Date:	30 November 2017	
	Engineer:	Gildas Colleter	
	DEHP Coastal Segment:	FRC047	
	Start coordinates	152.671764232, -25.2449565559	
	End coordinates	152.675724521, -25.2458581927	
	Tide	Low during inspection (3 hours on-site)	
	Asset Certification	Yes, RPEQ	
	Other associated assets	Stair access Beach accesses Fence Signs Private properties	
NOTE: This document has been prepared as an Asset Condition Survey Report for Fraser Coast Regional Council. JBP accepts no responsibility or liability for any use that is made of this document other than by the Client for the purposes for which it was originally commissioned and prepared.

Structure type:	Rock armour revetment		
Approx. defence length (m):	375m		
Approx. co-ordinates from:	152.672570672, 25.2450582158	to:	152.67518283, 25.2455802775
As built drawing available:	Yes		
Infrastructure protected:	Private property and public land

COASTAL ASSET CONDITION SURVEY REPORT

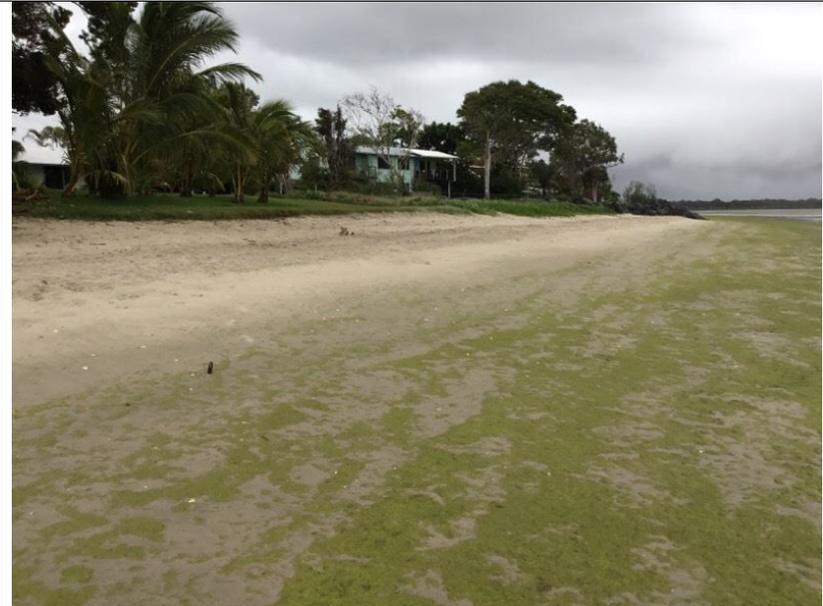
Looking towards the west - the seawall merges into the beach – Location Reference – “Inspection End”

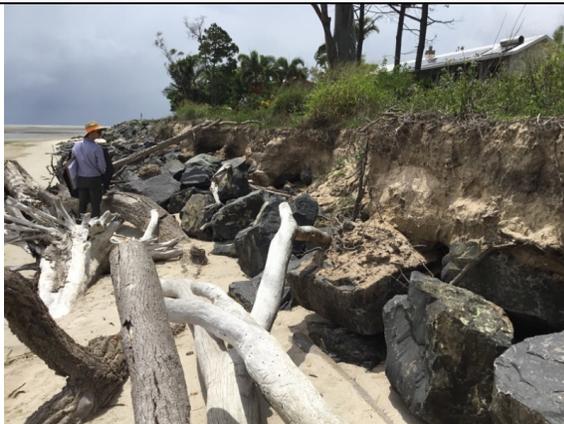
**Dune erosion to west – exposed trunk section
Ref No: P3**

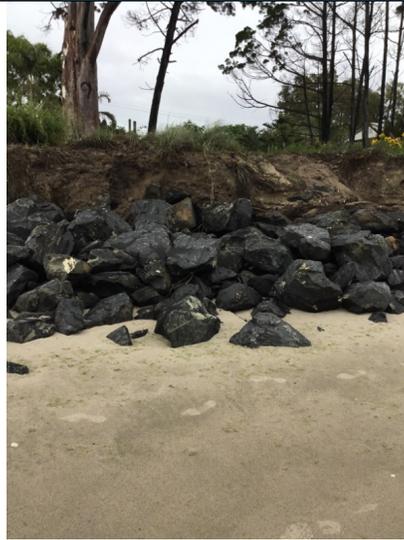
Property 52
Ref No: P18

P18	Property 50 – seawall	- 25.2450348580	152.672289153	1(+)	(+) condition grade assumed to be very good - the seawall has been buried since construction D7 Assess vegetation which may be threatened by erosion	Assess vegetation in erosion area Monthly monitoring of scarp	Band C – Short-Term Assess vegetation in erosion area Monthly monitoring of scarp
P19	Property 48 – seawall	- 25.2450048849	152.672057714	1(+)	(+) condition grade assumed to be very good - the seawall has been buried since construction	Monthly monitoring of scarp	Monthly monitoring of scarp
P20	Dune accretion to East	- 25.2455802775	152.675182830	N/A	East-end of wall covered by beach Vegetation cover “goat foot”. Shoreline is eroding towards the east of the seawall (exposed tree roots).	Long-term monitoring	Monitor – 6 months unless event
P20	Property 76 - Entrapment void	- 25.2455802775	152.675182830	2	D1 Large void in trunk	Void to be closed-out with smaller rocks and rock spalls	Band A- Emergency

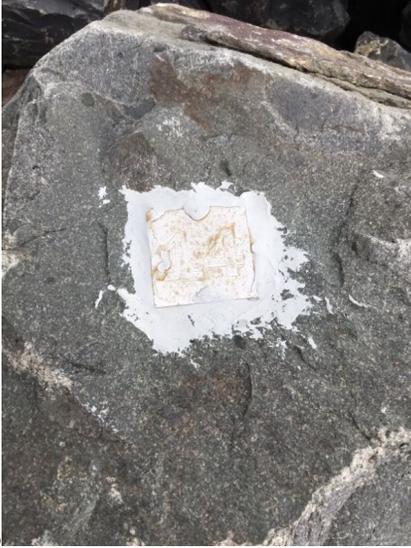
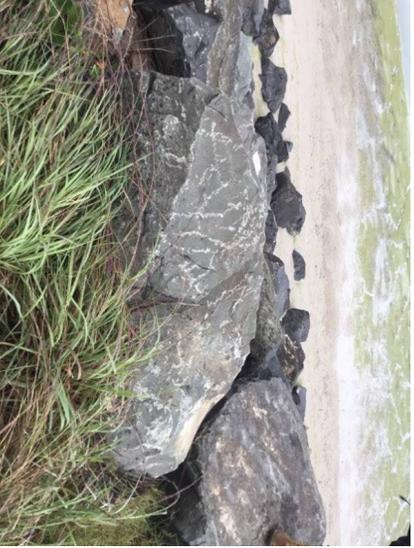
<p data-bbox="300 802 495 829">Found in Nov. 2015</p>
ID14

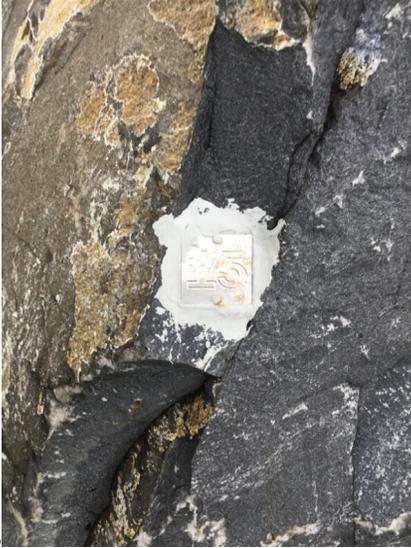
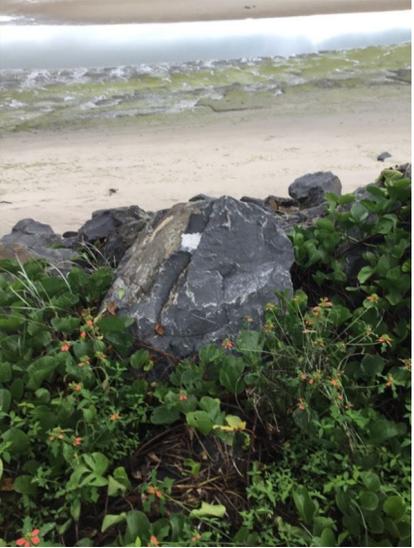
<p data-bbox="300 1358 495 1386">Found in Nov. 2015</p>
ID15

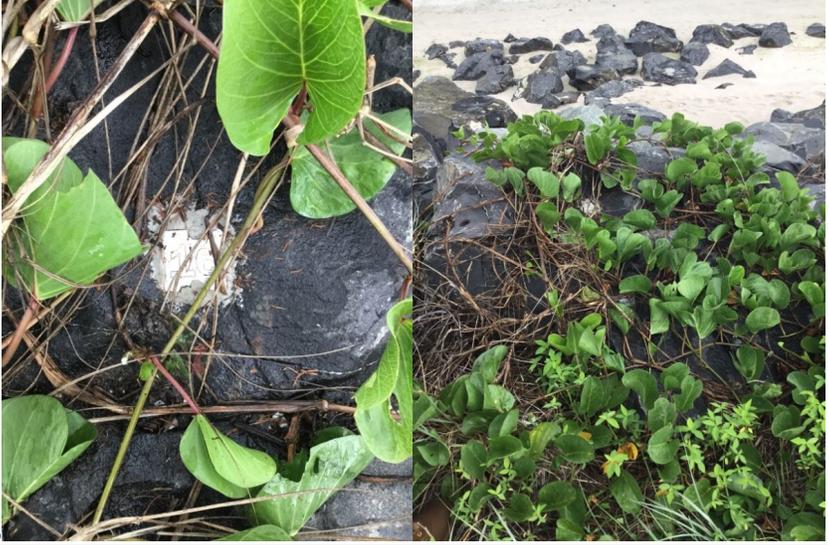
Marking Plate ID	Photograph / Notes	
ID16

<p data-bbox="300 808 495 829">Found in Nov. 2015</p>	
ID17

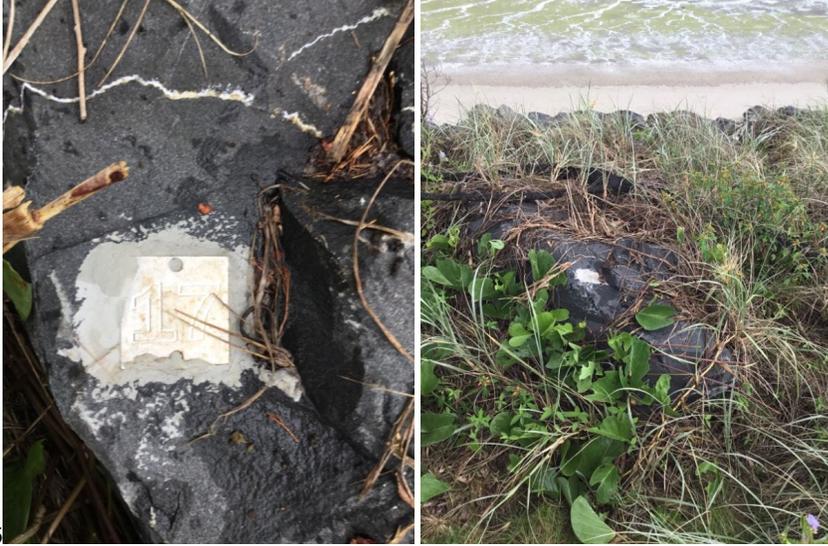
<p data-bbox="300 1360 495 1381">Buried in Nov. 2015</p>	
ID18

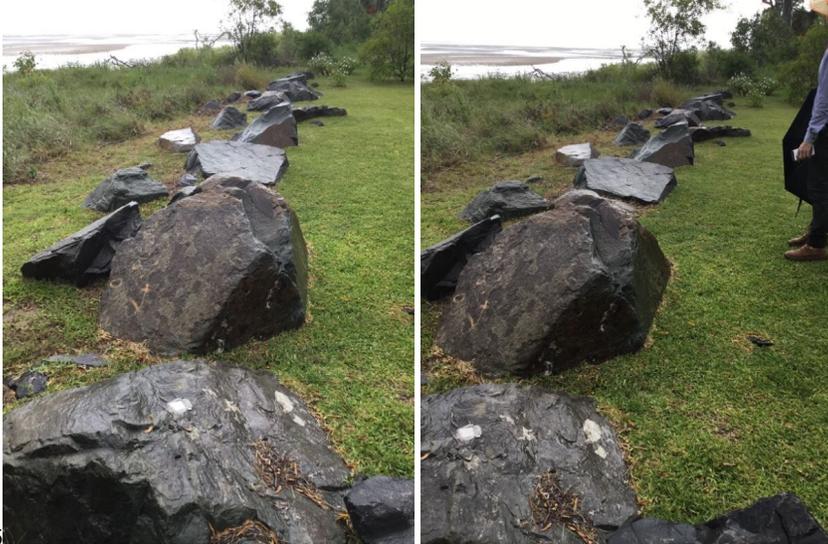
<p data-bbox="300 1911 495 1932">Buried in Nov. 2015</p>

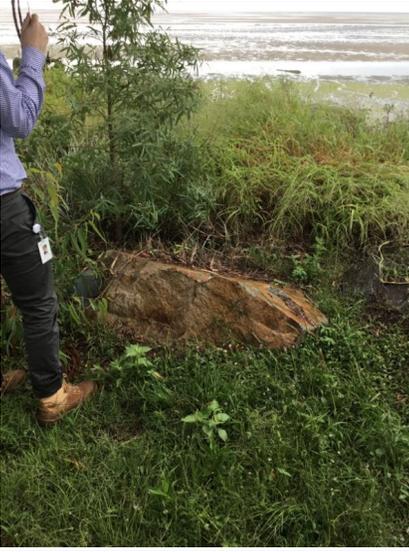
Marking Plate ID	Photograph / Notes
ID19

<p data-bbox="300 798 495 829">Buried in Nov. 2015</p>
ID20

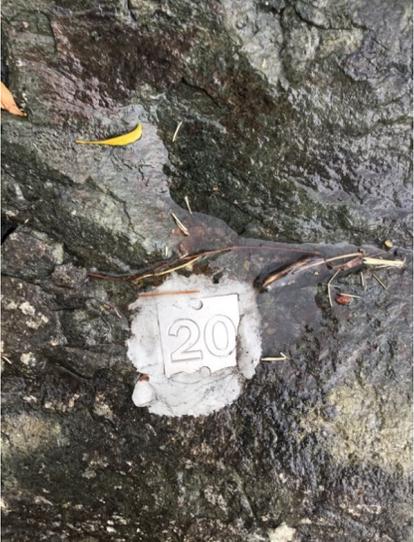
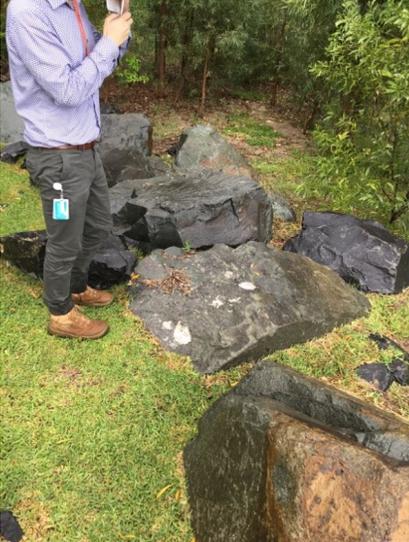
<p data-bbox="300 1354 495 1375">Buried in Nov. 2015</p>
ID21	Not found, may be buried since Nov. 2015
ID22	Not found, may be buried since Nov. 2015
ID23	Not found, may be buried since Nov. 2015
ID24	Not found, may be buried since Nov. 2015
ID25	Not found, may be buried since Nov. 2015

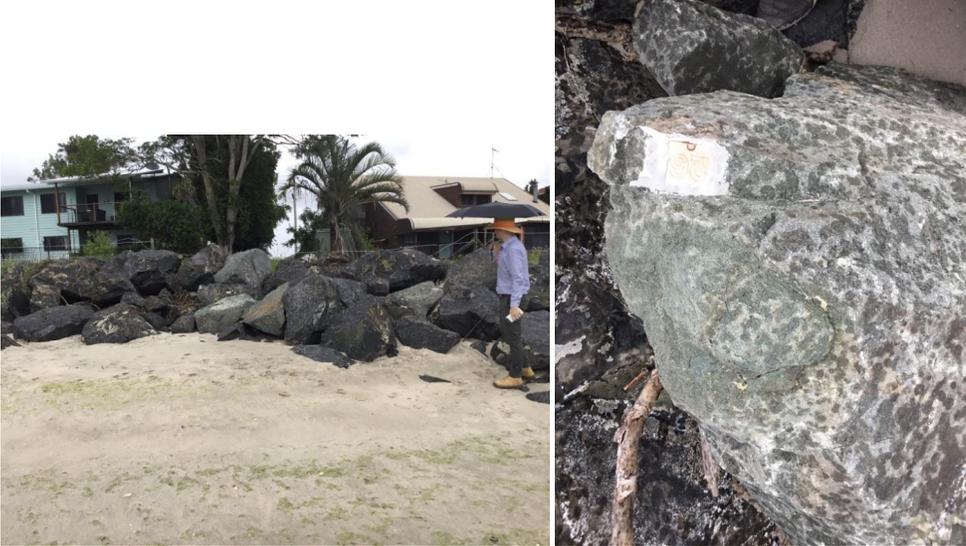
Marking Plate ID	Photograph / Notes
ID26	<p data-bbox="300 277 576 304">Was not found in Nov. 2015</p>

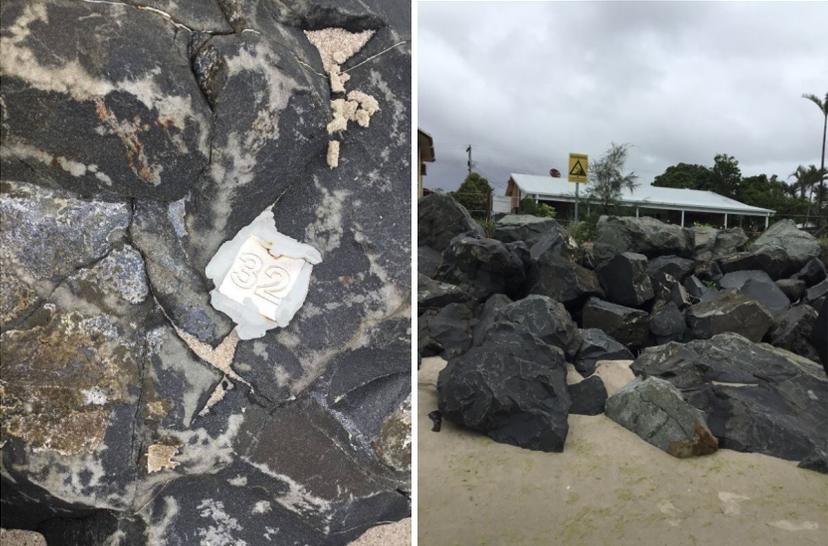
<p data-bbox="300 1512 495 1539">Found in Nov. 2015</p>
ID33	Not found, may be buried since Nov. 2015 or this could also be a missing plate
ID34	Not found, may be buried since Nov. 2015 or this also be a missing plate

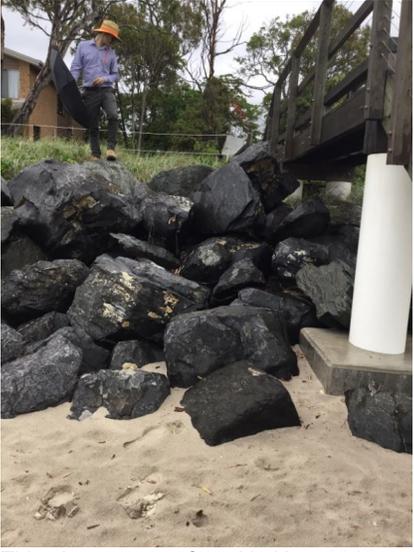
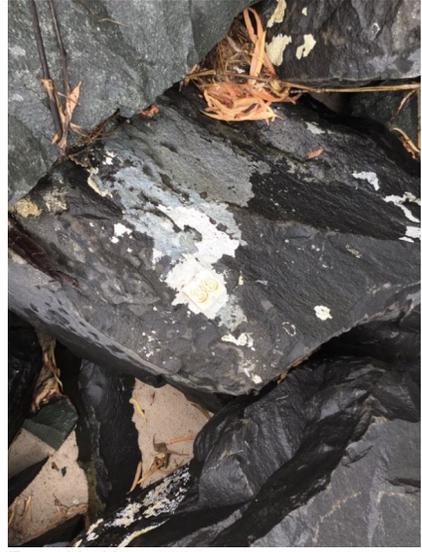
<div style="margin: 0 10px; text-align: center;">36</div>

</div> <p data-bbox="300 829 714 850">This plate was not found in Nov. 2015</p> <p data-bbox="852 829 1274 850">Found in Nov. 2015</p>
ID37	Not found in Nov. 2017. This plate was found in Nov. 2015. This could be a missing plate.
ID38	Not found, may be buried since Nov. 2015
ID39	Not found, may be buried since Nov. 2015
ID40	Not found, may be buried since Nov. 2015
ID41	<div style="display: flex; align-items: center;">

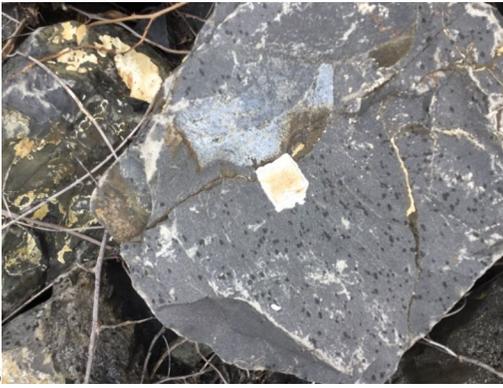
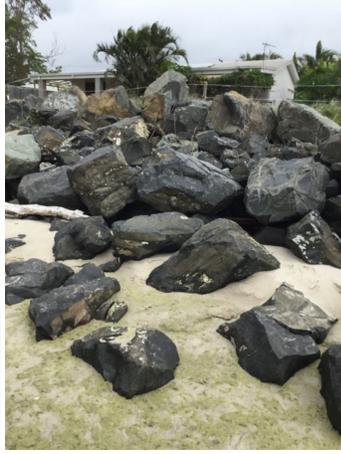
</div> <p data-bbox="300 1396 495 1417">Found in Nov. 2015</p>
ID42

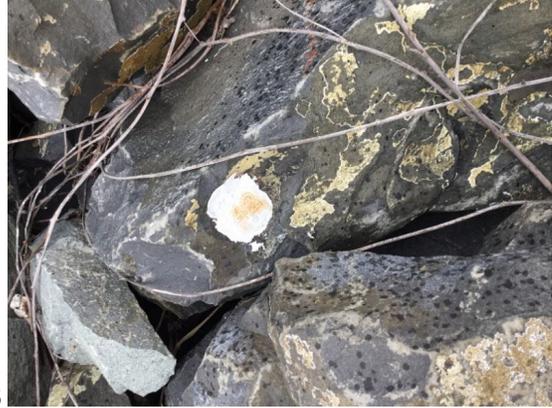
<p data-bbox="300 1806 495 1829">Found in Nov. 2015</p>

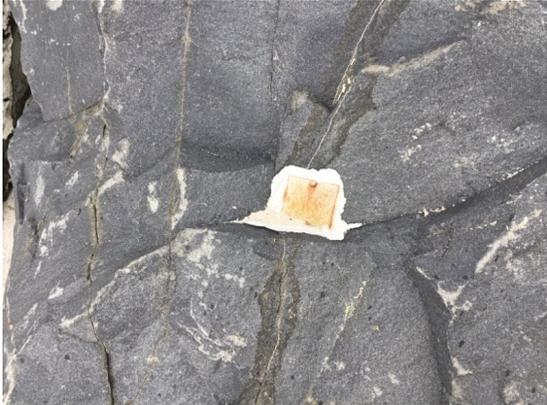
Marking Plate ID	Photograph / Notes
ID43

<p data-bbox="300 661 495 682">Found in Nov. 2015</p>
ID44

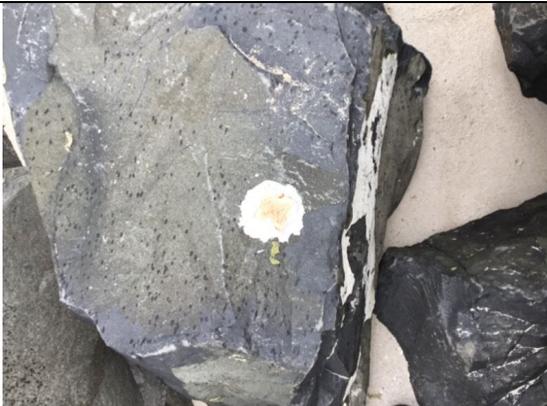
<p data-bbox="300 1071 495 1092">Found in Nov. 2015</p>
ID45	<p data-bbox="300 1096 1031 1127">Not found, may be buried since Nov. 2015 or this could be a missing plate</p>
ID46	<p data-bbox="300 1131 1218 1163">This plate was not found in Nov. 2017. It was found in Nov. 2015. This plate may be missing.</p>
ID47

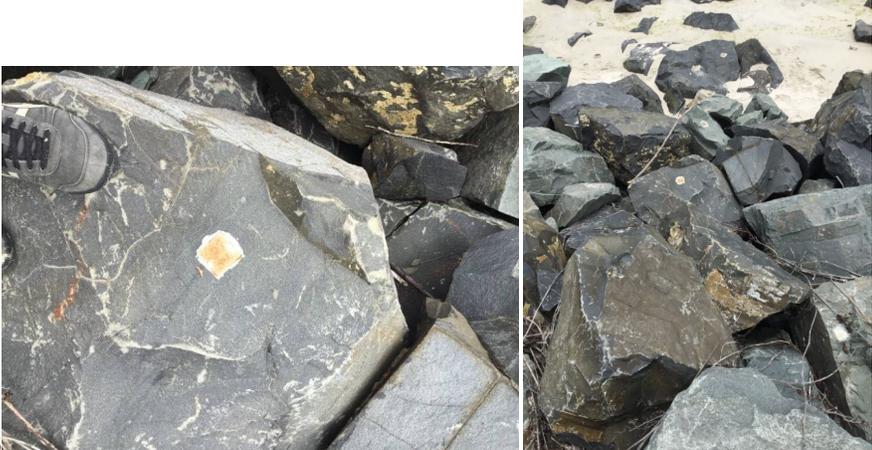
<p data-bbox="300 1596 495 1617">Found in Nov. 2015</p>

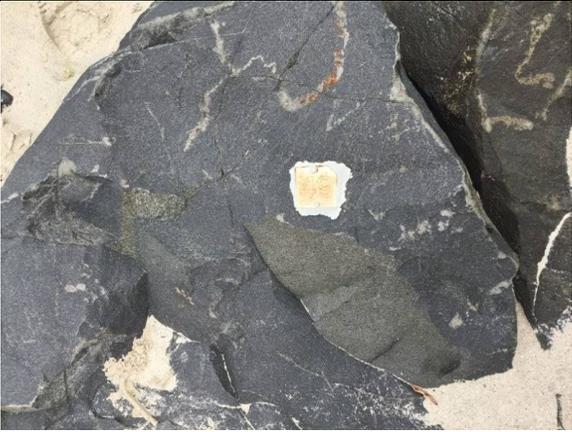
<p data-bbox="300 1186 500 1211">Found in Nov. 2015</p>
ID50	<p data-bbox="300 1215 1495 1241">This plate was not found in November 2017. It was found in Nov. 2015..</p>
ID51	<p data-bbox="300 1245 1495 1270">Not found, may be buried since Nov. 2015</p>
ID52

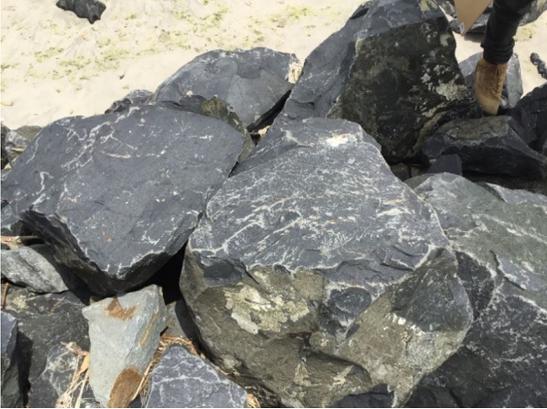
Marking Plate ID	Photograph / Notes
ID53

<p data-bbox="300 688 1494 709">This plate was buried in Nov. 2015, Glue visible only. Stainless steel Plate ID 53 is missing</p>
ID54

During the inspection 28 marking plates were found, one damaged armourstone (Plate ID 48) and no defective armourstones amongst the 28 armourstone sample. 7x marking plates (33, 34, 37, 45, 46, 53 and 54) appear to be missing and should be re-instated on the seawall.

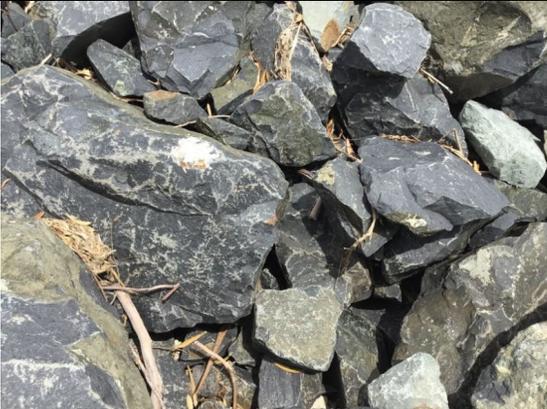
<p data-bbox="300 1123 1494 1144">This plate was buried in Nov. 2015, Glue visible only. Stainless steel Plate ID 54 is missing</p>
ID55	Not found, may be buried since Nov. 2015
ID56	Not found, may be buried since Nov. 2015
ID57	Not found, may be buried since Nov. 2015
ID58	Not found, may be buried since Nov. 2015
ID59	Not found, may be buried since Nov. 2015
ID60	Not found, may be buried since Nov. 2015

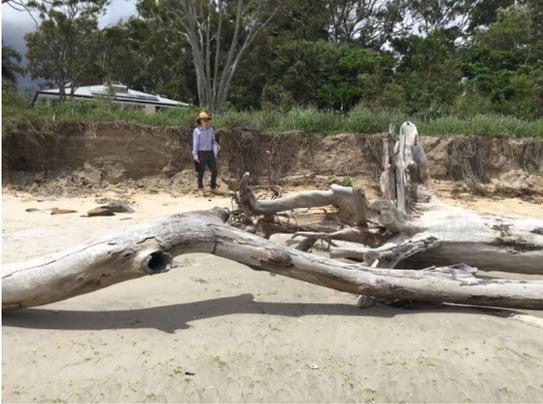
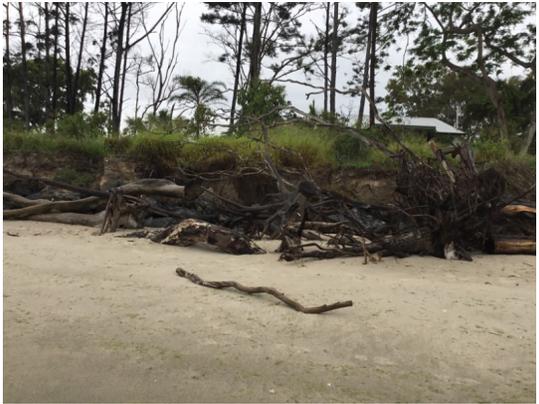
<p data-bbox="293 924 1380 945">Seawall is buried – No damage on capping stones N=0, D=0</p>
#50

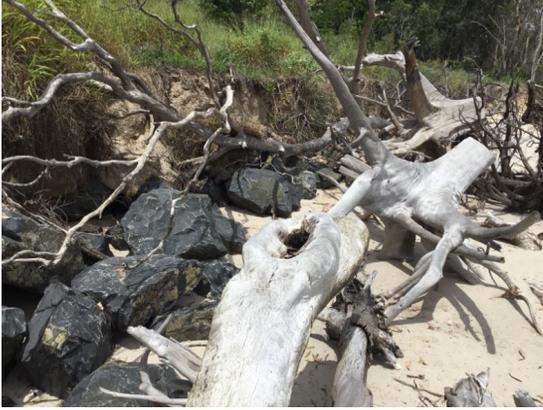
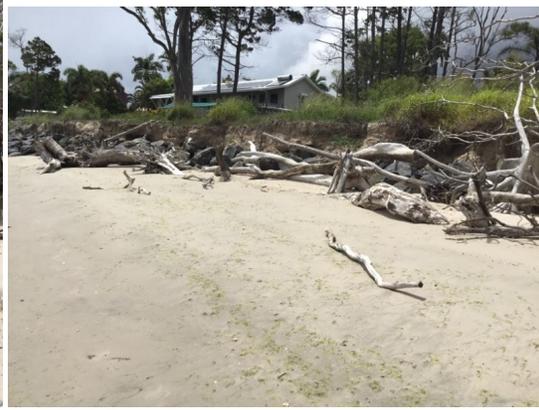
<p data-bbox="293 1365 1380 1375">Approximately 1 armourstone height visible along the dune - N=8,D=0</p>
#52

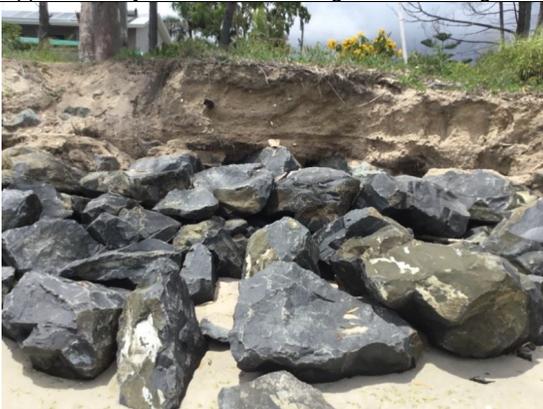
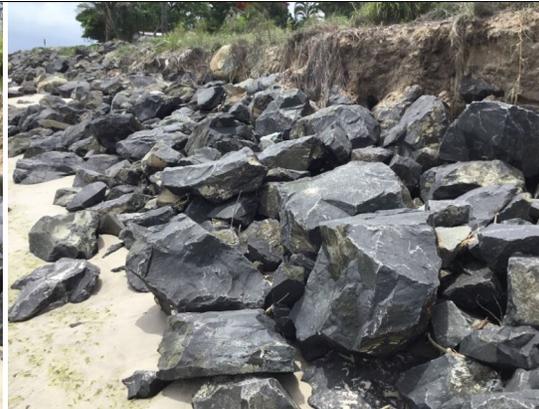
<p data-bbox="293 1795 1380 1848">2-3 height armourstones visible (trunk). Large trees noted in the dune erosion footprint. Minor unpacking, TBC N=21,D=0 N=16, D=0</p>

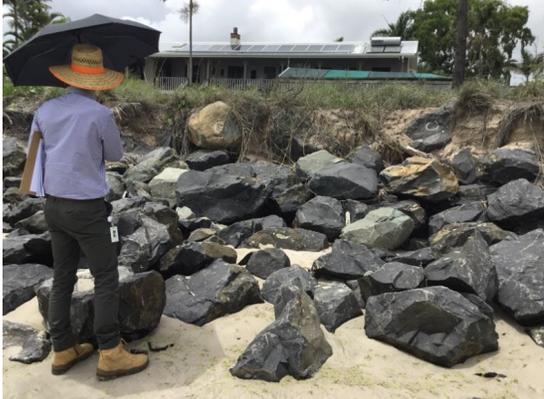
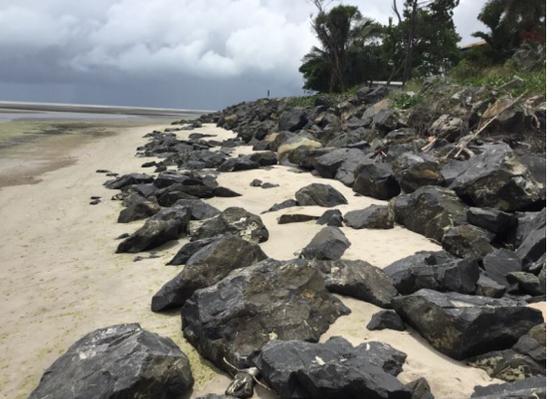
<p>Top of toe is visible at low tide, start of transition to trunk full exposure, 2-3 armourstone unpacking N=28, D=0</p>	
#58

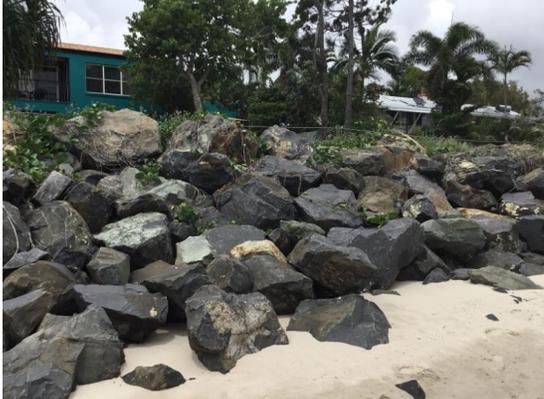
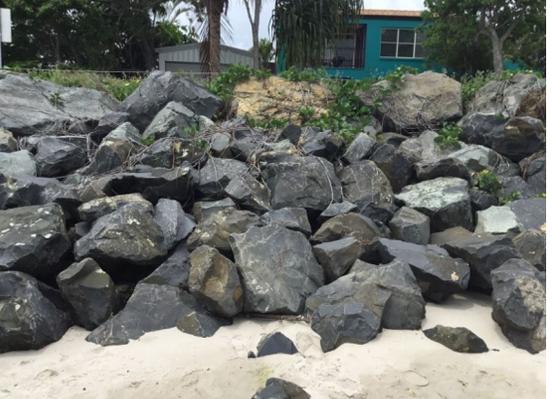
<p>N=23, D=0</p>	<p>N=30, D=0</p>
#60

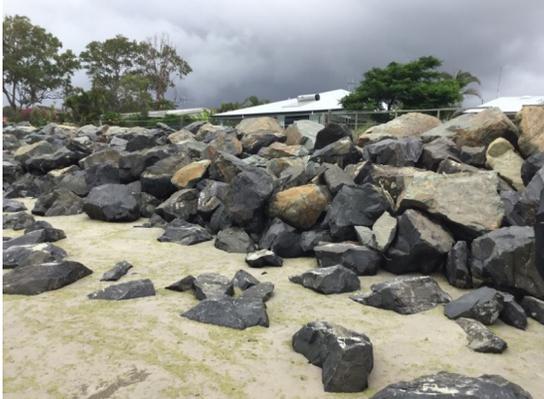
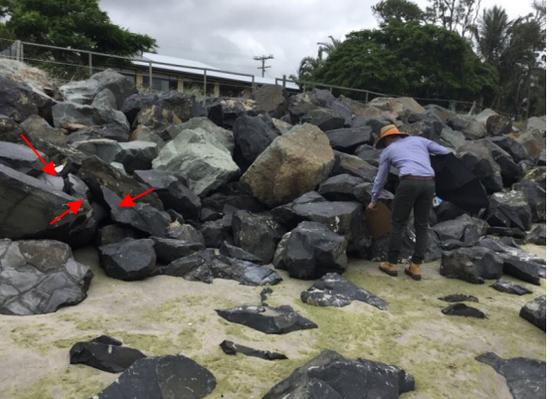
<p>N=32, D=0</p>	<p>N=28, D=1 – minor rock spalls present</p>

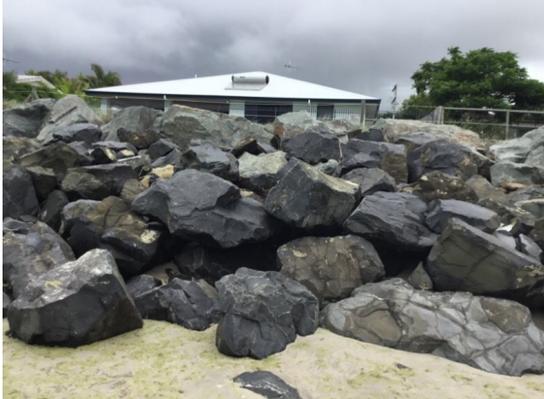
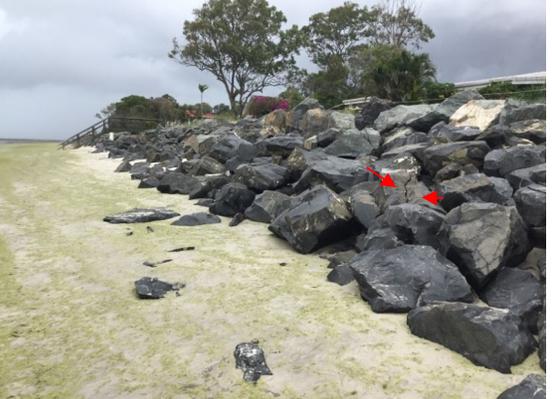
N=27, D=0	N=27, D=1 – high packing density
#64

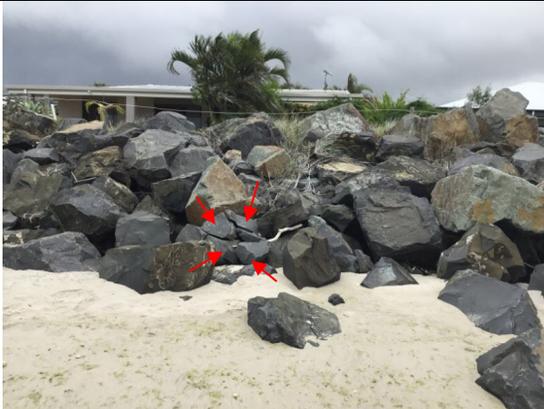
N=24, D=1	N=18, D=0 – Unpacking of 1 armourstone, some spalls
#66

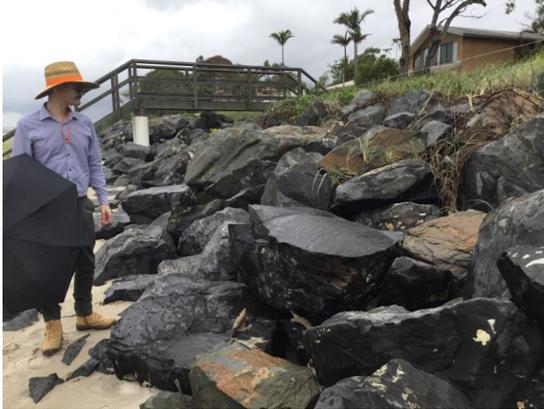
N=16, D=0	N=16, D=0 – high packing density

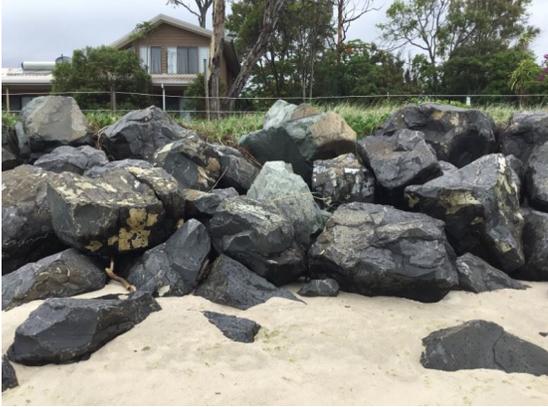
Property Number	Picture, comments and armourstone count (N) and damage (D) quantification	
#70

<p data-bbox="293 688 406 709">N=19, D=0</p>

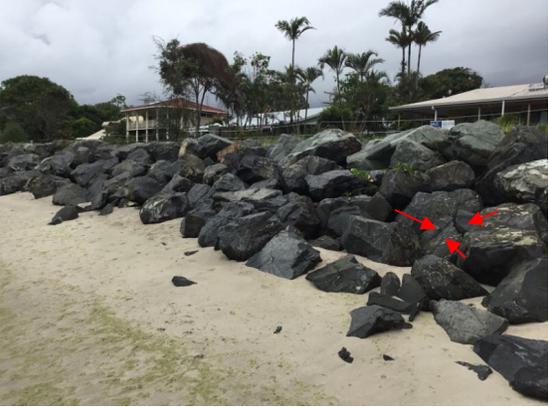
<p data-bbox="850 688 1198 709">N=25, D=1 – good packing density</p>
#72

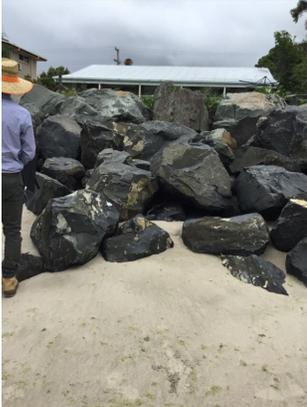
<p data-bbox="293 1123 406 1150">N=14, D=0</p>

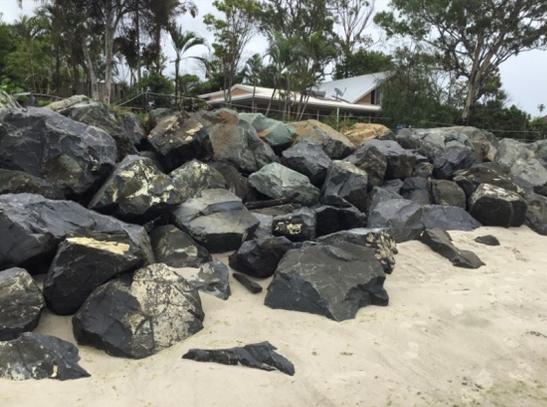
<p data-bbox="610 1123 954 1150">N=30, D=0 – good packing density</p>
#74

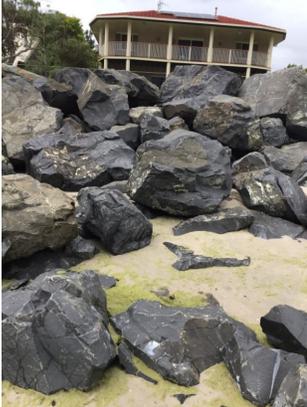
<p data-bbox="293 1564 406 1589">N=12, D=0</p>

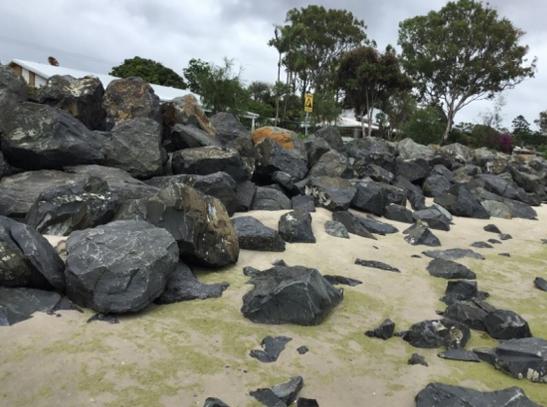
<p data-bbox="610 1564 1291 1589">N=18, D=0 – unpacking of 1 or 2 armourstones, some spalls present</p>

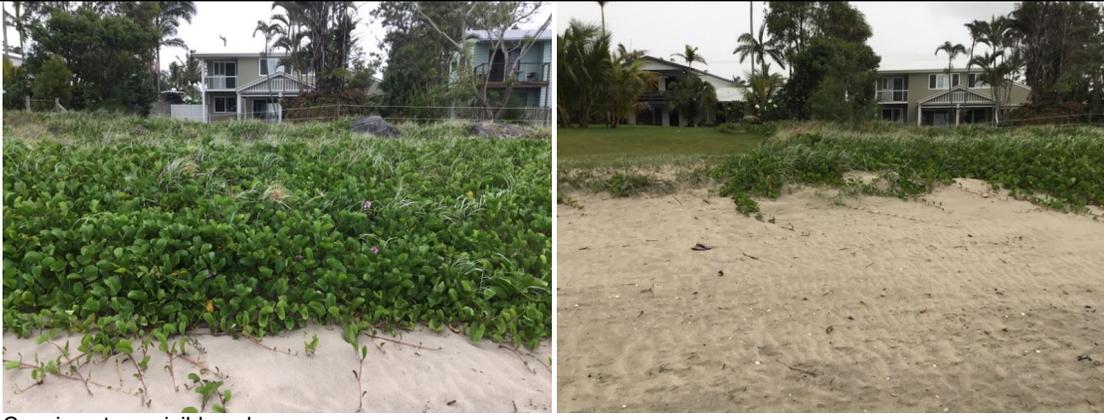
#80

N=19, D=0

N=19, D=0 – unpacking of 2-3 armourstones, some rock spalls present

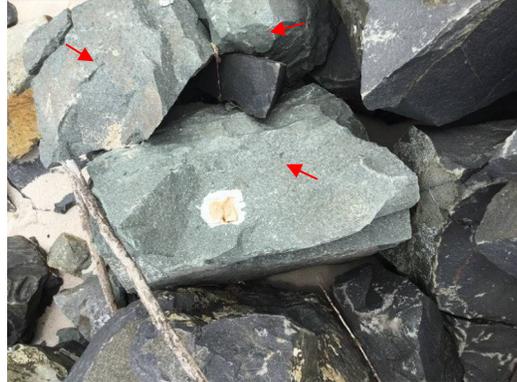
Damage 1 on Marking Plate 48- multiple fractures and residual armourstone likely 750kg or less - Damaged since November 2015. The armourstone seems not to be originating from Dundorwan Quarry - #58. Appears to be a mechanical fracture

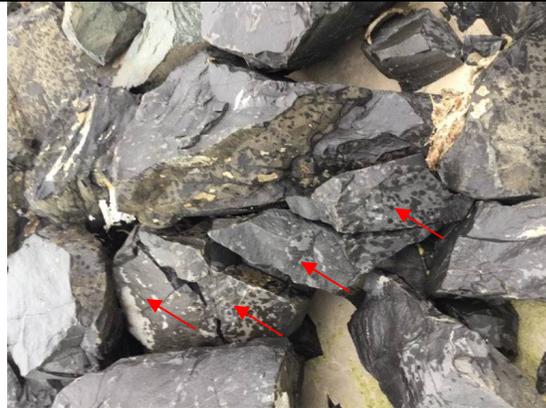
Damage 3 - multiple fractures and residual armourstone likely 750kg or less - #62. Multiple fracture planes

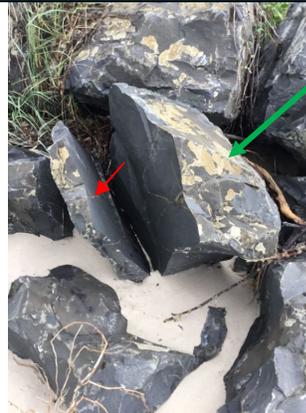
Defect- Spalling with main armourstone likely >1t - #78

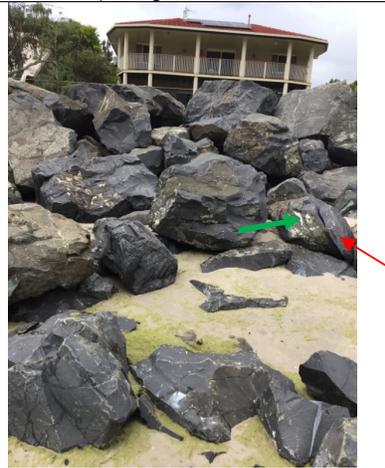
Defect- spalling with main armourstone likely >1t - #74

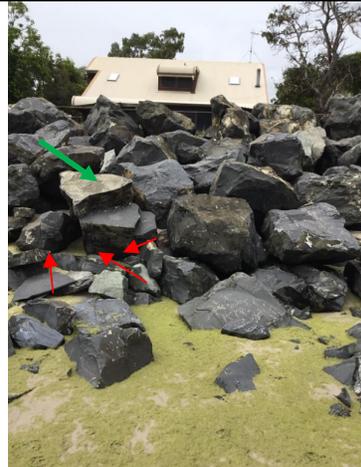
Defect- Spalling with main armourstone likely >>1t - #76
